Draft Final Report • National Institute of Standards and Technology (NIST)

of the May 22, 2011,
Tornado in
Joplin, Missouri

NIST NCSTAR 3 (Draft)

November 2013

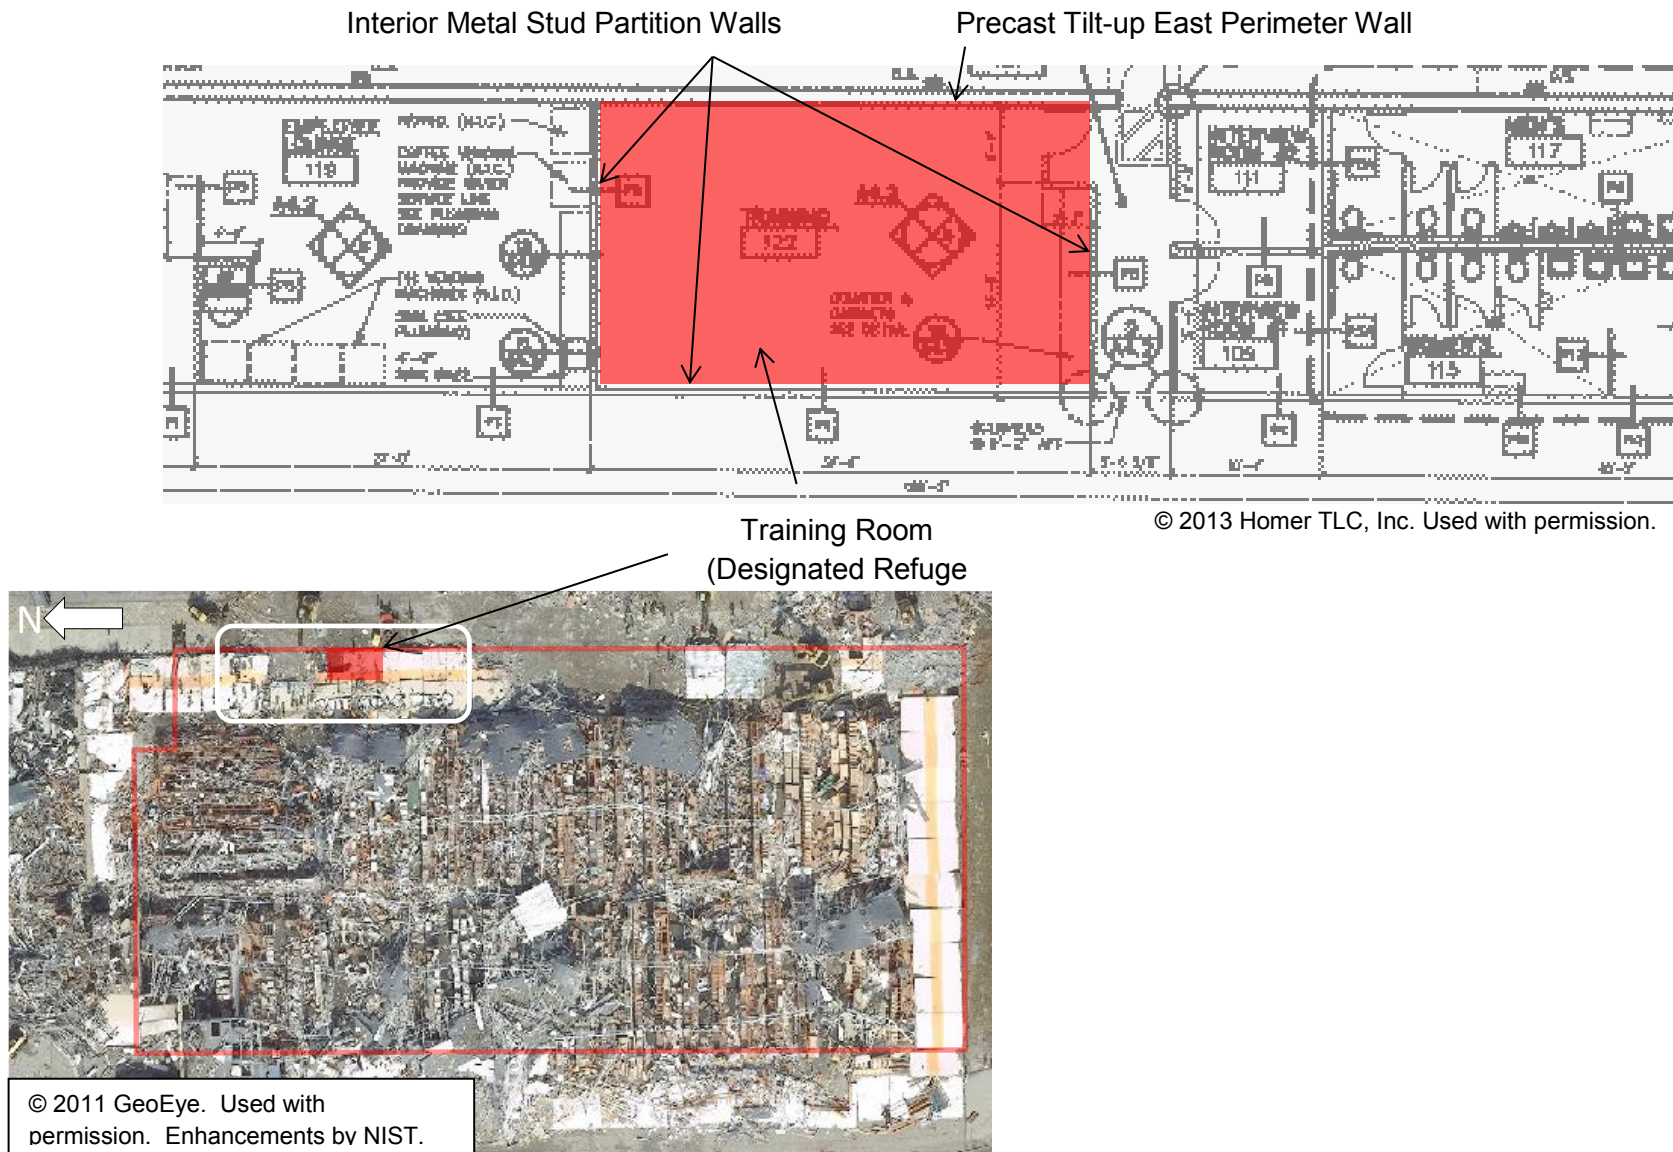
Design drawings indicated that the Training Room/designated refuge area was 34 ft × 20 ft in plan, and bounded by the hard tilt-up east perimeter wall on the east side and three interior partition walls on the north, south, and west sides. The interior partition walls were made of steel stud frames (6 in. wide, 20-gauge, 16 in. on center), covered with 5/8 in. gypsum boards on one side and 1/2 in. plywood panels on the other. The hard wall that bounded the east side of this room comprised tilt-up wall panels that did not have positive connections to the concrete strip footing. North of this room was a group of wall panels (around the loading dock) that had some rotational capacity due to their positive wall-to-footing connection (designed for accidental truck collisions with the dock, see Fig. 3-46 in Sec. 3.2.1.3). The roof system was structurally similar throughout the store's interior. Thus, structurally speaking, the area along the same (east perimeter) wall and about two wall panels north of the Training Room (adjacent to the locker room near the loading dock, see Fig. 3-121) might have been a better selection for the best available refuge area in this store.

Figure 3-120. Location of the Training Room/designated refuge area at the Home Depot. Perimeter tilt-up wall panels here collapsed inward and onto the safe area.

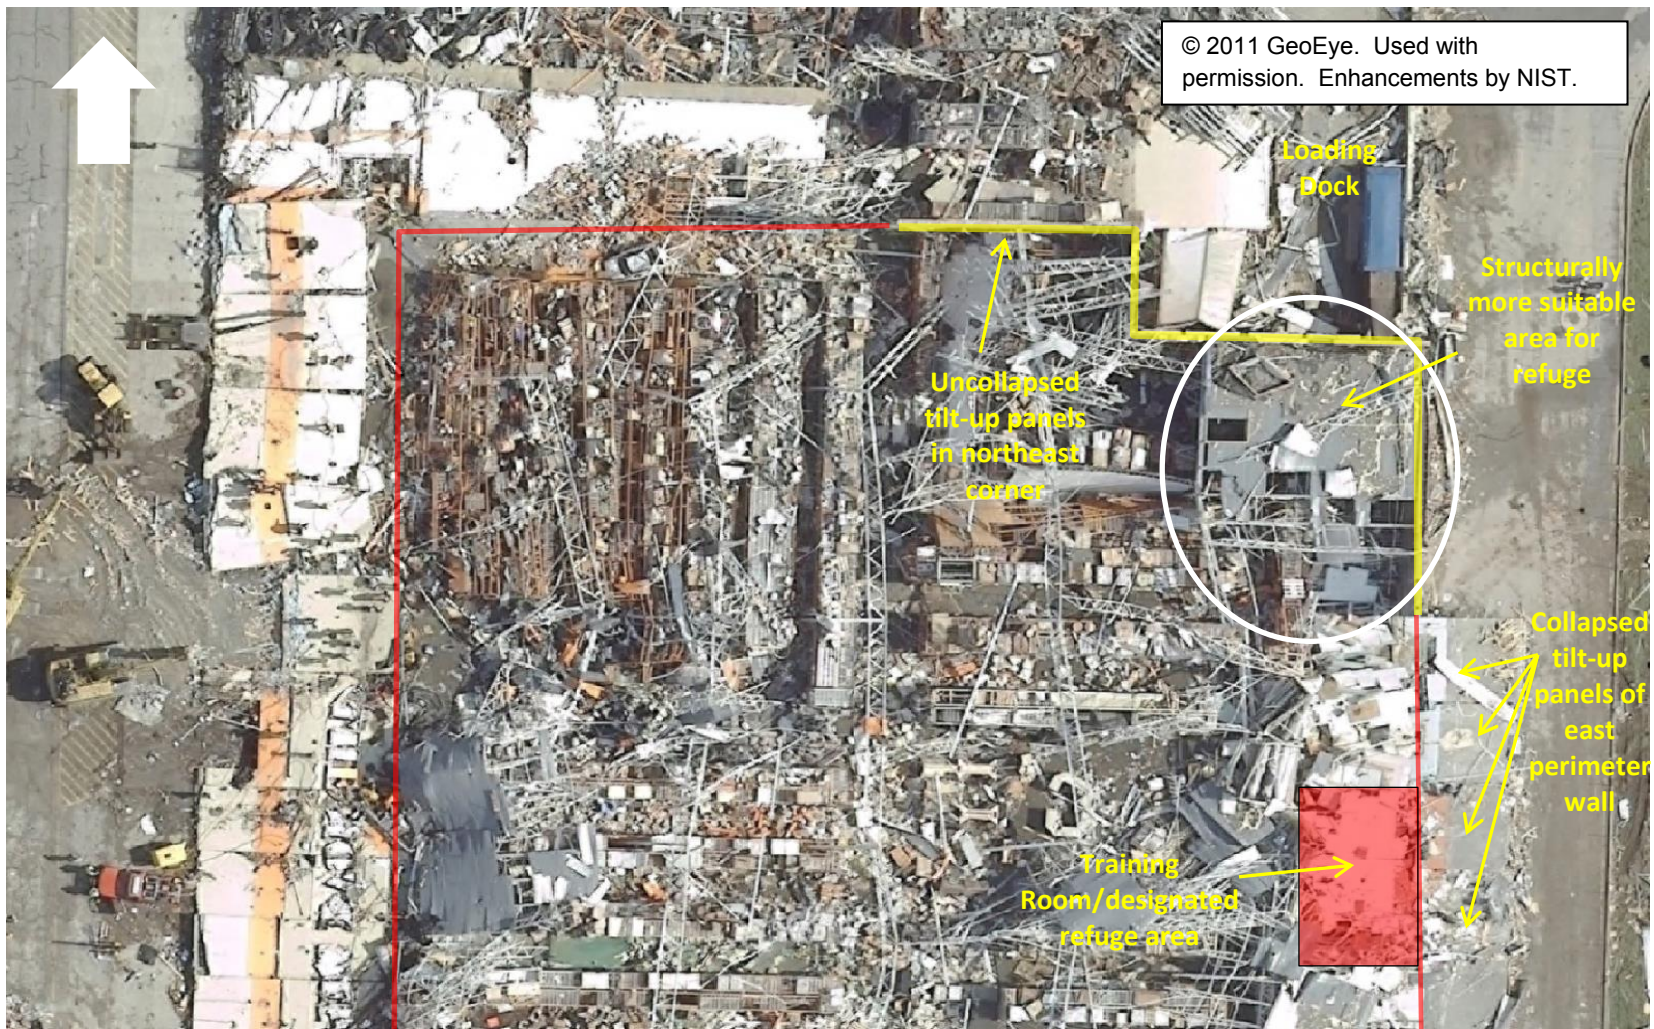
Figure 3–121. North section of the Home Depot. Red line indicates perimeter tilt-up wall panels that collapsed. Yellow line traces perimeter tilt-up wall panels (northeast corner, around loading dock) that did not collapse. Red rectangle designates the Training Room/designated refuge area.

As discussed in Sec. 3.2.1.3, the Home Depot sustained total collapse in the Joplin tornado, with 63 of its 73 tilt-up perimeter hard wall panels collapsing either inward toward the interior of the building or outward away from the interior of the building. The perimeter hard wall panels that bounded the designated refuge area were among the 63 that collapsed. However, they fortuitously collapsed outward away from the building and the refuge area in the Training Room (see Fig. 3–121 and 3–122), and thus averting the potential for further injuries or fatalities among the building occupants who might have sought shelter in this area.

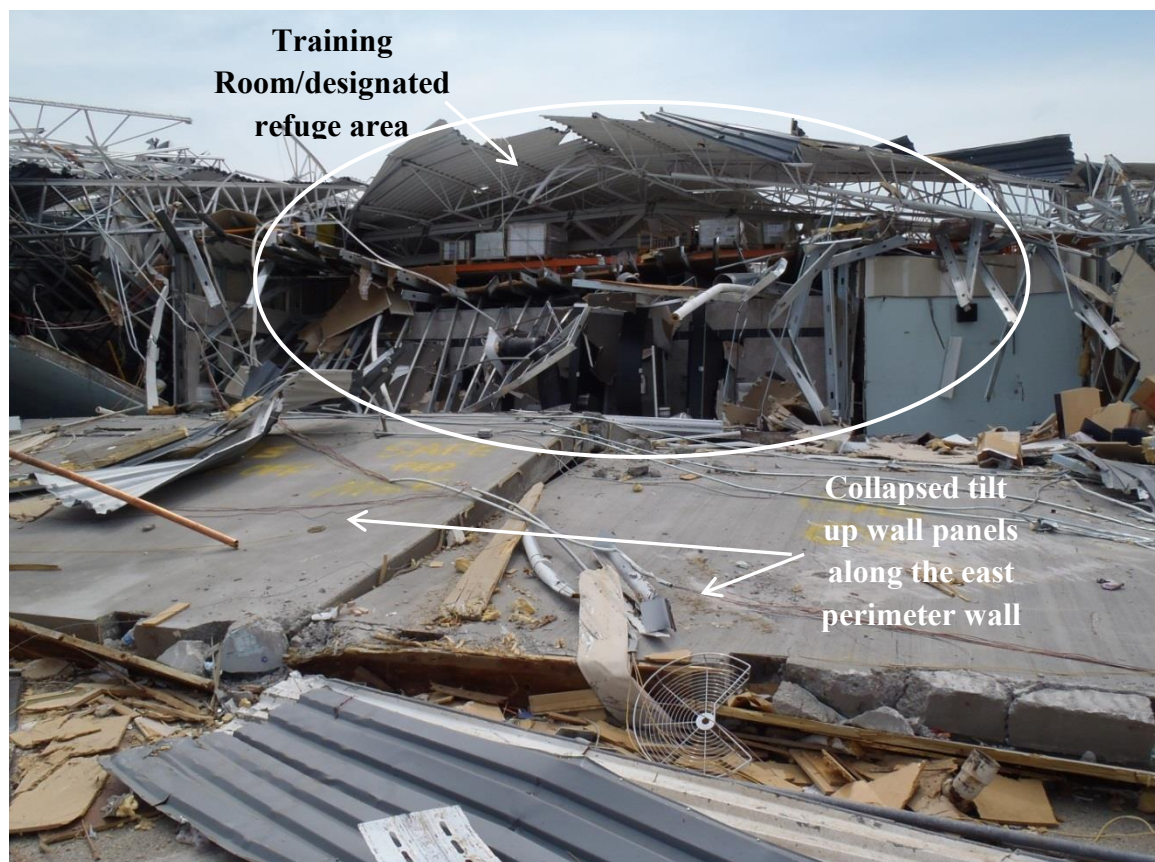
In summary, the designated refuge area in the Home Depot did not provide better protection than other areas in the store during the May 22, 2011, Joplin tornado. An area near the loading dock may have been structurally more suitable to serve as a refuge, since the hard walls of this area had additional rotational capacity due to the design of the wall-to-footing connections. NIST does not have information on how the designated refuge area at this Home Depot was selected, including whether an experienced and qualified architect or engineer was consulted. Currently, such consultations are not mandatory and the selection can be done at the discretion of the facility owner. There were eight fatalities and an unknown number of injuries at the Home Depot. While media accounts indicated that there were injuries that occurred to occupants of the designated safe area, NIST was not able to obtain direct confirmation of the locations of the injuries and fatalities at this facility (see Chapter 4) including the designated refuge area.

Figure 3–122. View, from outside toward the west, of the Training Room/designated refuge area of the Home Depot.

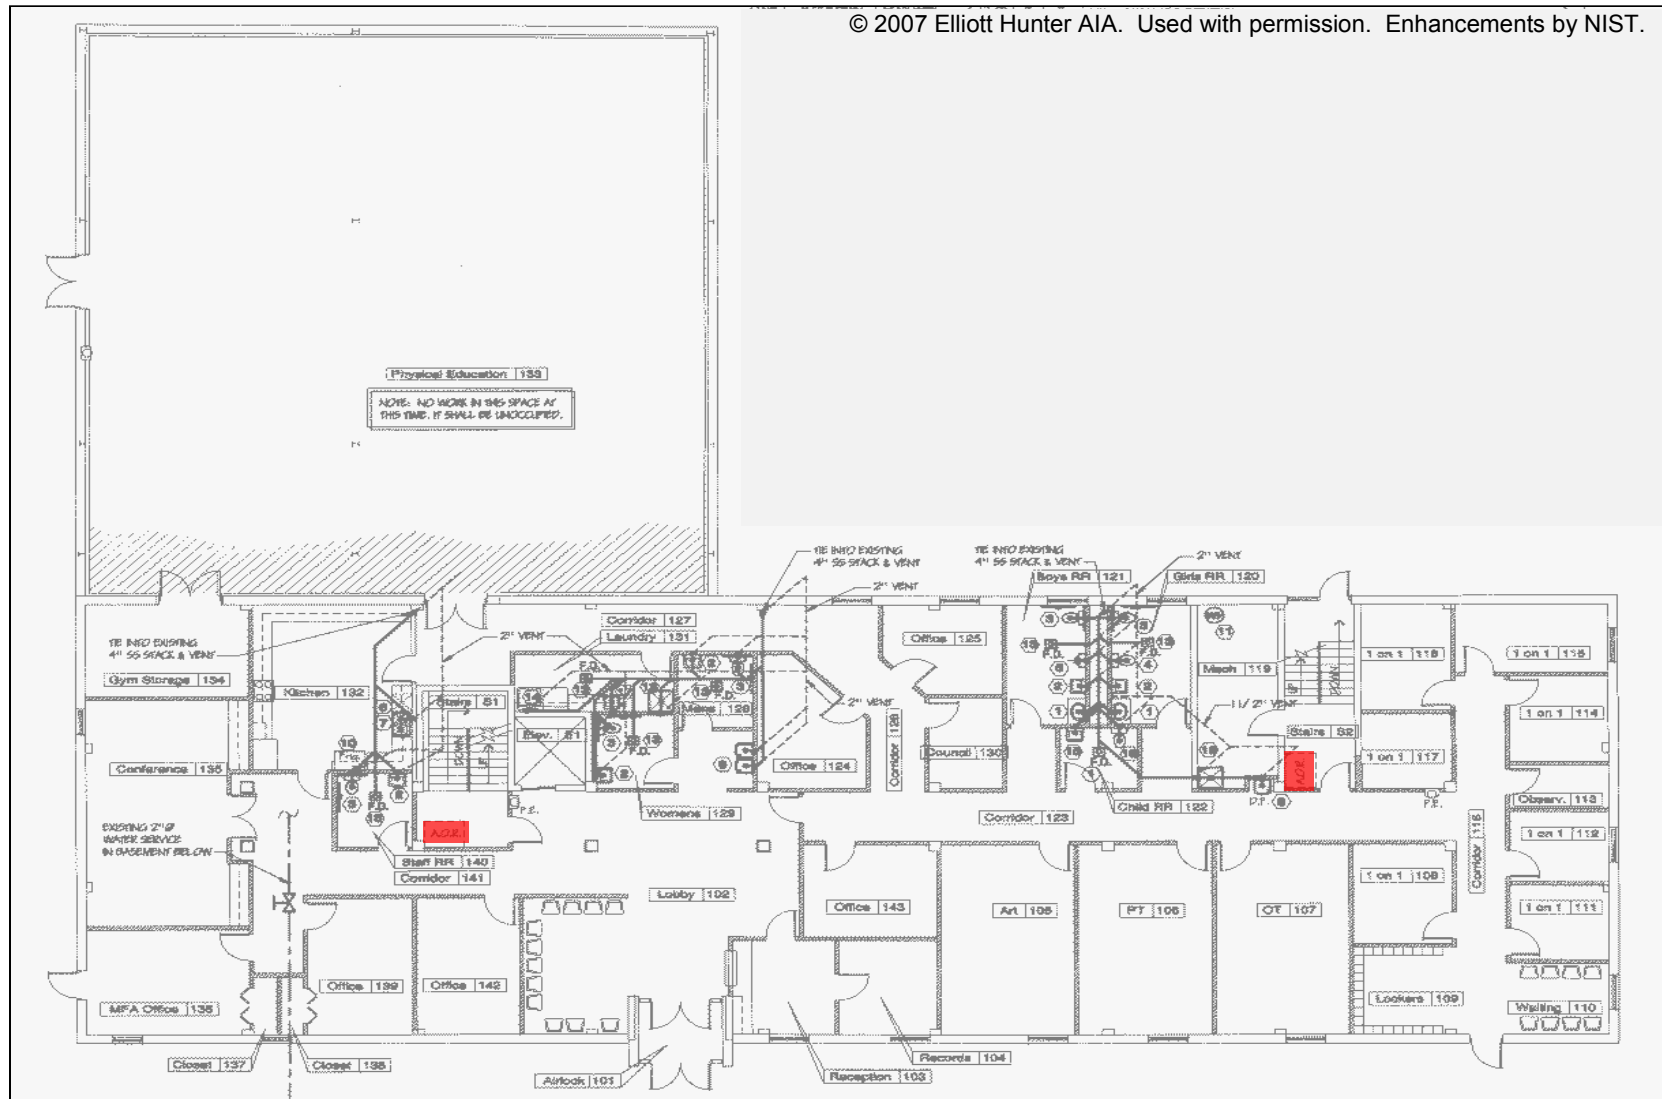
As discussed in Sec. 3.2.2.1, the RC frame Ozark Center for Autism building sustained significant damage to its envelope and interior, but no structural damage to its MWFRS. Design drawings showed that the building had two designated “areas of refuge” located in the two stairwells of the building (see Fig. 3–125). These two areas were protected on all sides by reinforced CMU wall enclosures. Damage survey observations found that, while the building interior sustained significant damage as a result of wind and debris infiltration after the failure of the building envelope, the reinforced CMU stairwell enclosures were not damaged and thus would have continued providing protection for any refuge occupants.

Figure 3–125. Locations of areas of refuge (AOR, red blocks) on the first floor of the Ozark Center for Autism building.

building to tornado hazards despite the building's strong MWFRS), the two designated "areas of refuge" appeared to have been appropriately selected. With the protection afforded by the reinforced CMU wall enclosures and their easy accessibility for building occupants, these areas represented the best available refuge areas compared with all other areas of this building.

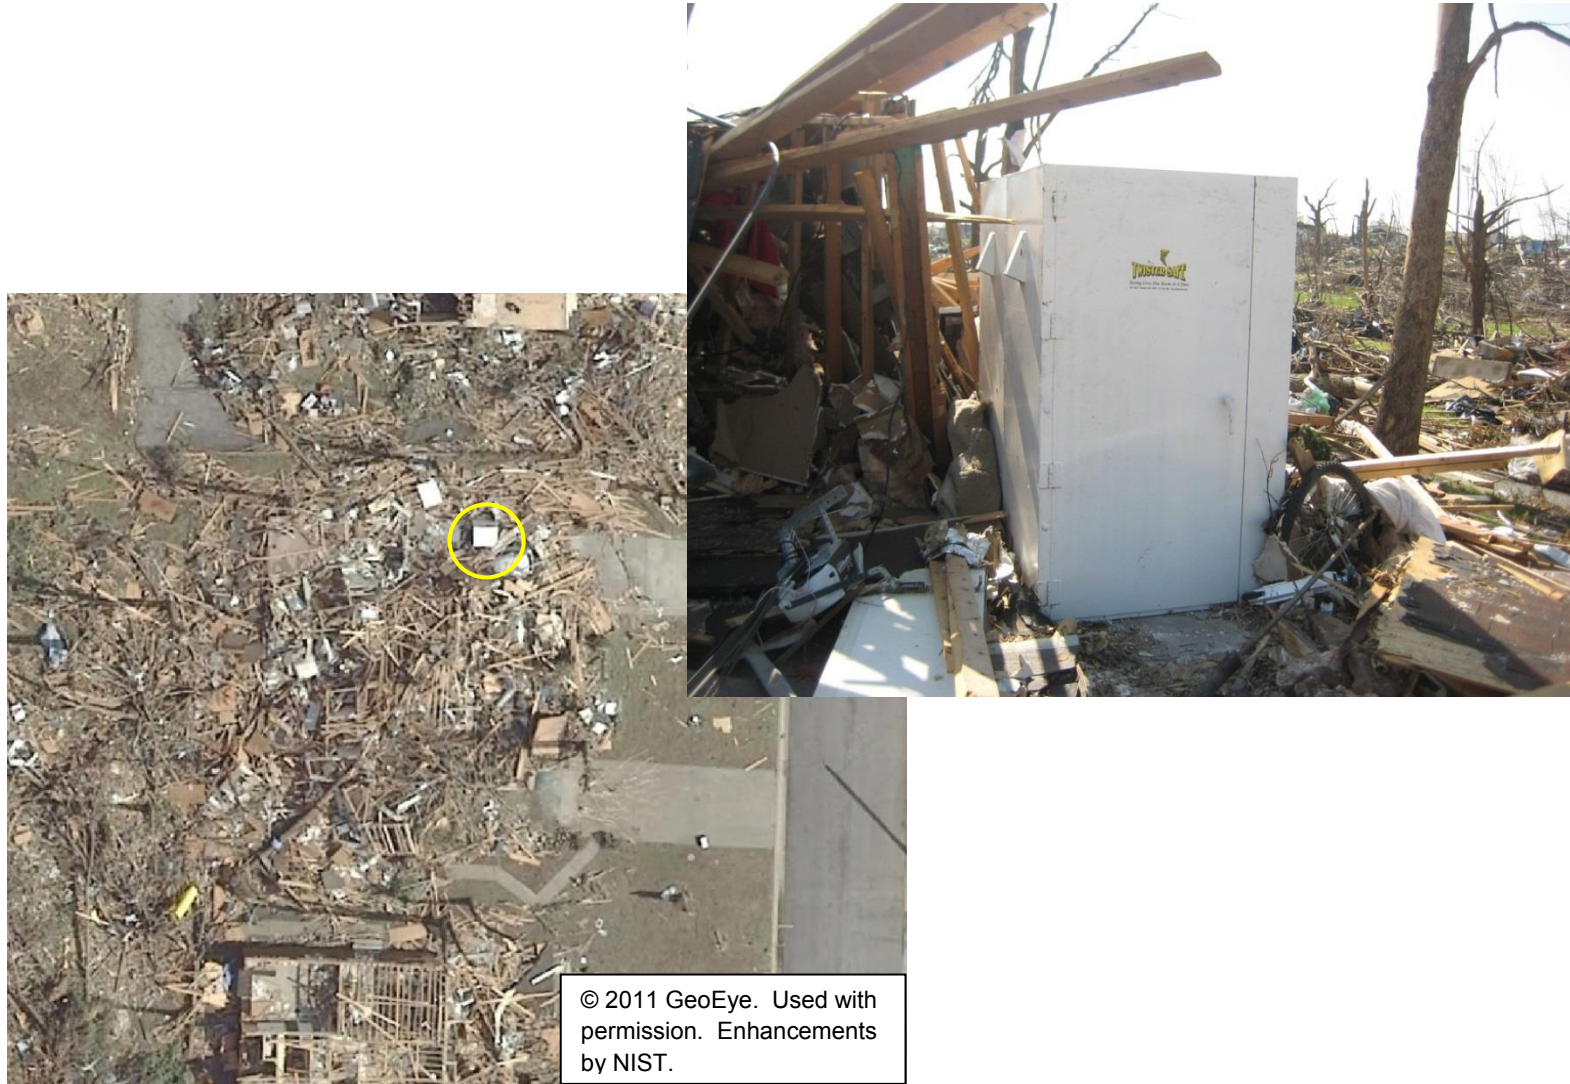
An above-ground portable steel shelter was installed in a home on South Adele Avenue, in close proximity to the estimated center of the tornado damage path and directly west of SJRMC. The wood-frame home and surrounding similarly constructed homes in this area sustained complete demolition (see Fig. 3-128). The home belonged to a family who had experienced a tornado and lost one family member as a result 3 years before in Racine, Missouri. This experience factored into the family's decision to install the portable steel shelter, which reportedly cost \$4,000, in the new family home on South Adele Avenue. As shown in Fig. 3-128, the wood-frame home was completely destroyed during the May 22, 2011, Joplin tornado, but the steel shelter was not damaged and remained anchored to the concrete garage floor. The homeowner and his daughter, who took shelter in this storm room, emerged unscathed.

Figure 3–128. Wood-frame home completely destroyed except for the steel shelter bolted to the concrete floor in the garage.

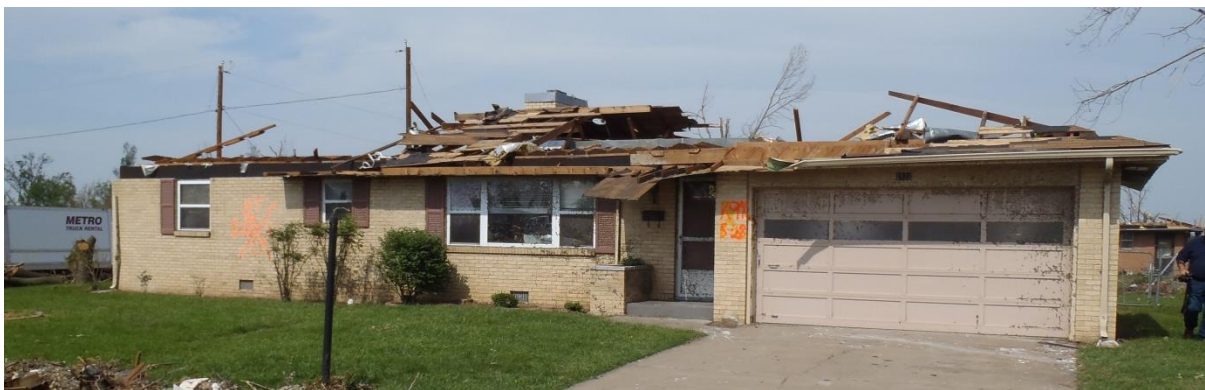
An above-ground Kevlar-reinforced shelter was installed at a wood-frame home located on Alabama Avenue, west of SJRMC and in an area that sustained significant damage (see Fig. 3-129). The 4 ft × 4 ft shelter had Kevlar lining for its roof and walls, and was anchored onto the concrete garage floor using epoxy anchors. The home sustained significant damage, with the roof disconnected and lost and other damage to windows and the interior due to wind and debris infiltration. The shelter appeared completely intact, however, and the owner who took refuge in the shelter was unscathed (see Fig. 3-129 and 3-130).

Figure 3–130. Extent of damage (roof system disconnected) at residence with in-home, above-ground Kevlar storm shelter.

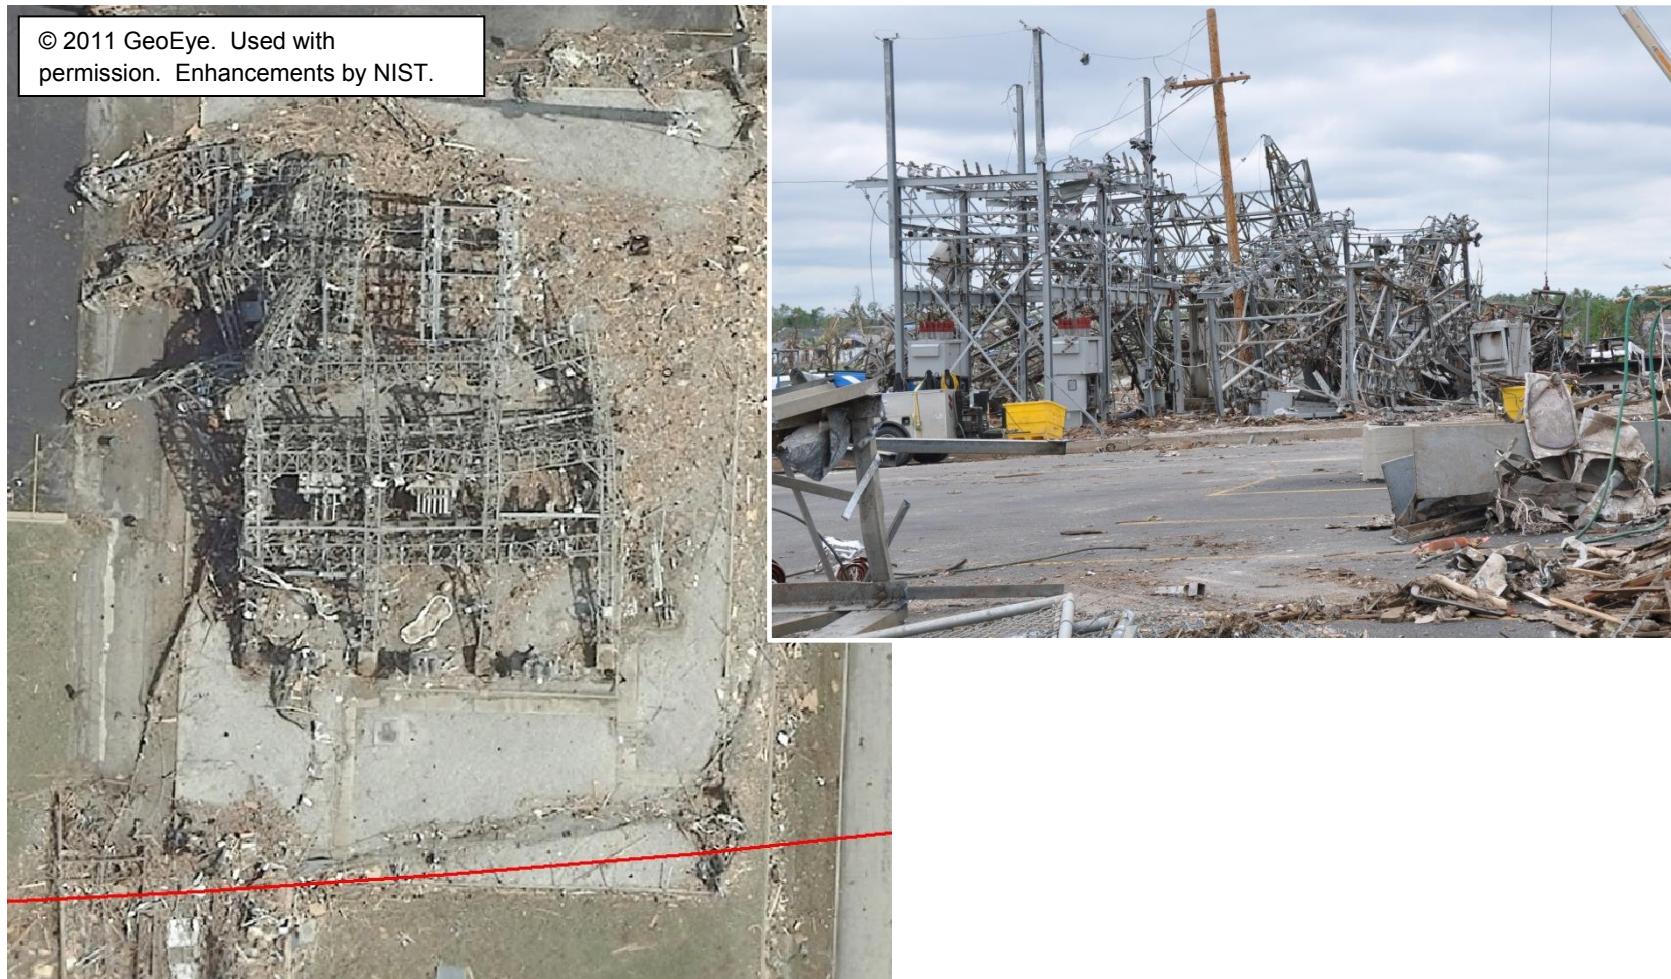
- 135 transmission towers affected.
- Substations
 - Six power substations with step-down transformers initially impacted. Two of these (Substations 422 and 430) were damaged but repairable. One was completely destroyed (Substation 59, open steel frame, in close proximity to the estimated center of the tornado damage path, see Fig. 3–131).
 - Several transformers at the damaged substations sustained damage and leaked.
- Distribution System
 - Approximately 110 miles of aerial distribution line downed.
 - Approximately 4,000 distribution poles damaged.
 - 31 of 60 circuits damaged.
- Fiber
 - 30 fiber lines cut.

Figure 3–131. Destroyed EDE Power Substation 59.

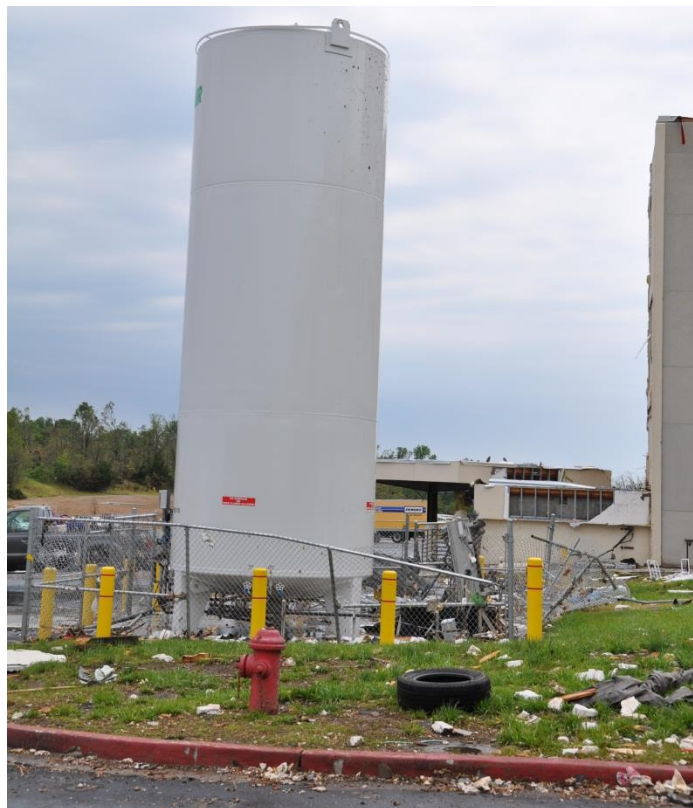
Figure 3–133. Liquid oxygen tank at SJRMC that leaked.

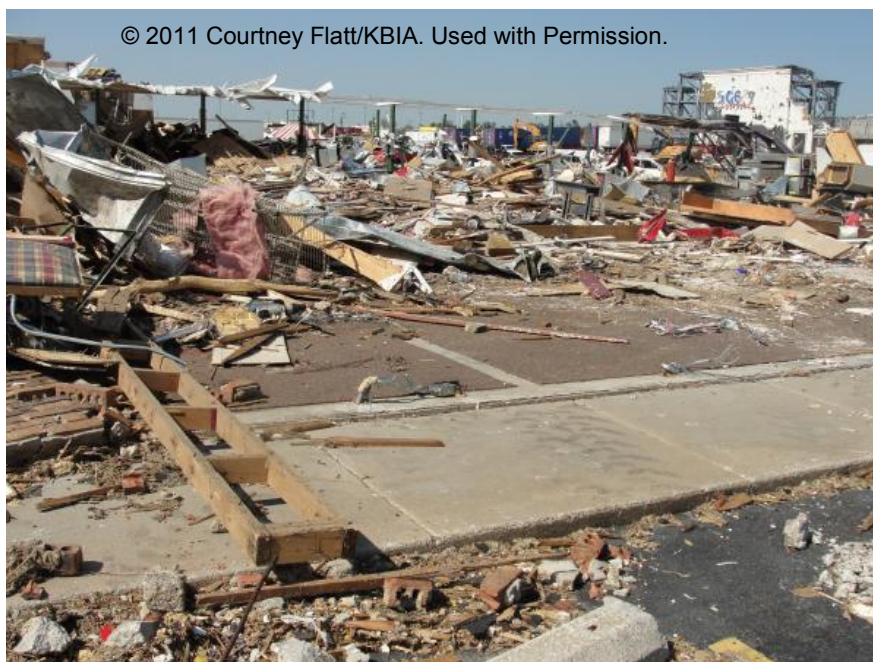
Figure 4–5. Joplin Elks Lodge #501 destroyed by the May 22, 2011, Joplin tornado.

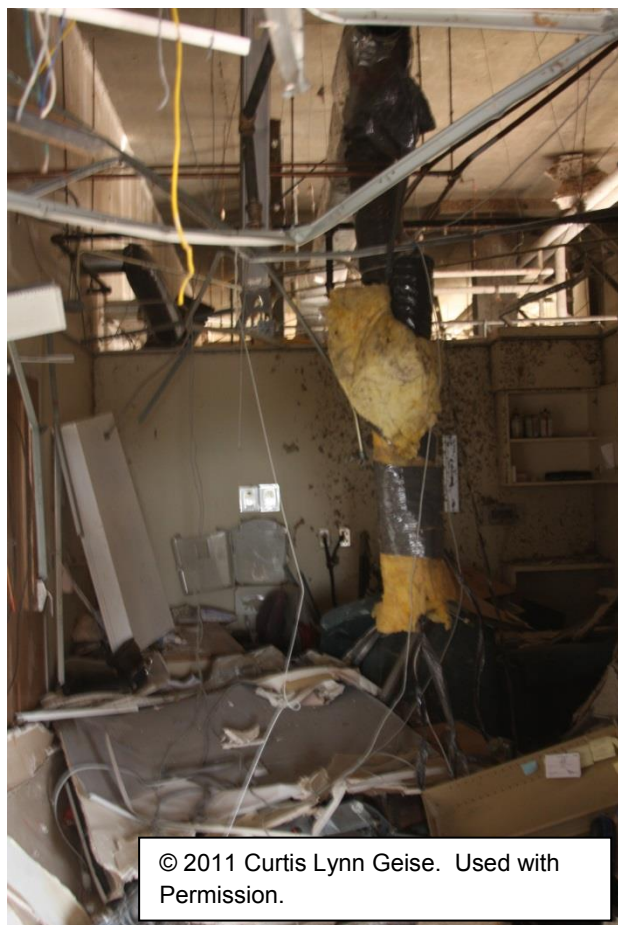
When the couple in the first-floor Emergency Room made it out of their examination room, they noticed the rain just pouring in from where the ceiling used to be. With water at their ankles, and live wires sparking around them, they were concerned about being electrocuted if they remained in the building for much longer (NIST Interview 2). See Fig. 4–6 for an example of damage done to the interior of the SJRMC.

Figure 4–6. Damage to the interior of SJRMC.

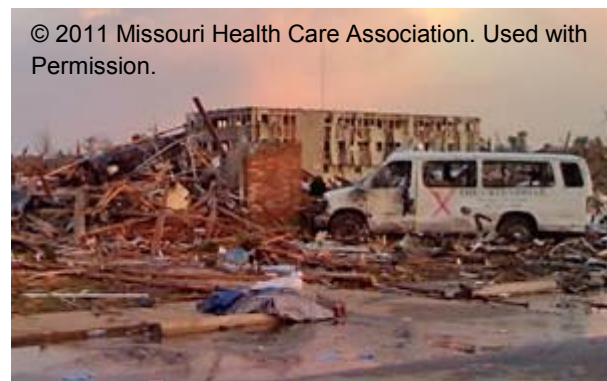
A total of 19 fatalities from the May 22, 2011, Joplin tornado are attributed to the Greenbriar Nursing Home, which was completely demolished by the tornado (see Fig. 4–7). All deaths were due to impact-related causes, except for one individual whose cause of death was pneumonia (and whose death occurred one month after the tornado hit), according to the death certificates. Five of the 19 fatalities were individuals who were injured at Greenbriar Nursing Home and later transported to hospitals where they died from their tornado injuries, according to the death certificates. No information was found on the exact cause of death for these five fatalities; only the cause of the injury that contributed to their death which was recorded on the death certificate. There was a media report that the cause of at least one of these five deaths was mucormycosis, a fungal infection that attacks the body after injury (Younker 2011a); however, NIST was not able to independently confirm that report.

Figure 4–7. The small brick wall in the foreground (to the left of the van) is one of the few portions of the Greenbriar Nursing Home left standing following the May 22, 2011, Joplin tornado. (The building standing in the background was not part of the Greenbriar.)

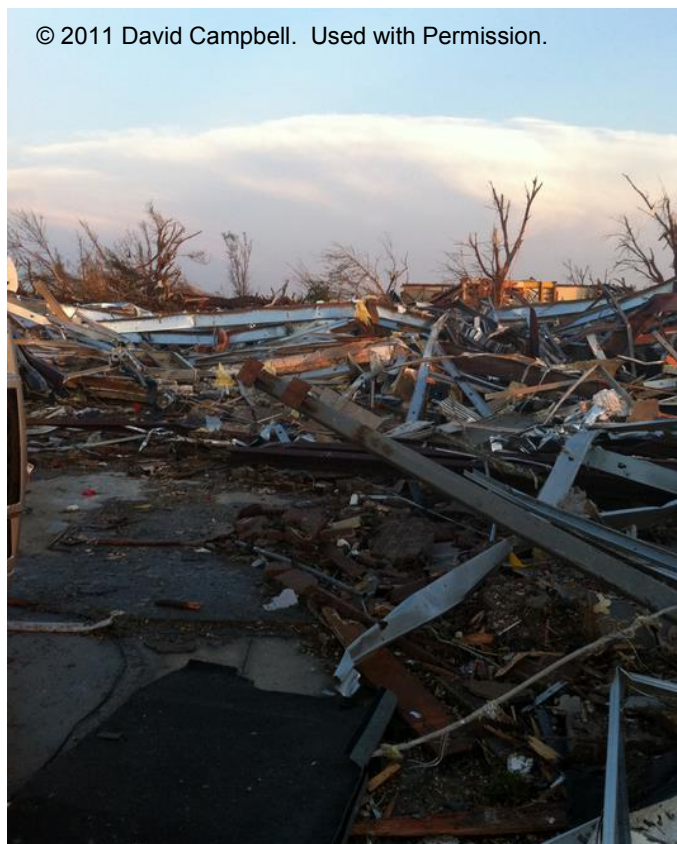
Figure 4-9. The AT&T store following the May 22, 2011, Joplin tornado.

The store was exposed to an estimated maximum wind speed of approximately 160 mph \pm 20 mph during the storm. One employee remembered the bathroom door coming off the hinges, slamming him in the back, and sending him flying into a brick wall (CWA 2011). Another employee recalled feeling for a moment like he was flying and then the sensation of being crushed, before he was knocked unconscious. When the storm was over, building materials and other debris had pinned some of the employees, so much so that they were unable to move. Those who could free themselves went for help, and those who remained realized that there was one death among them (i.e., an employee). One employee stated that the deceased was pinned down by a metal door (Skinner 2011). The severity of injuries to survivors at the AT&T store is unknown.

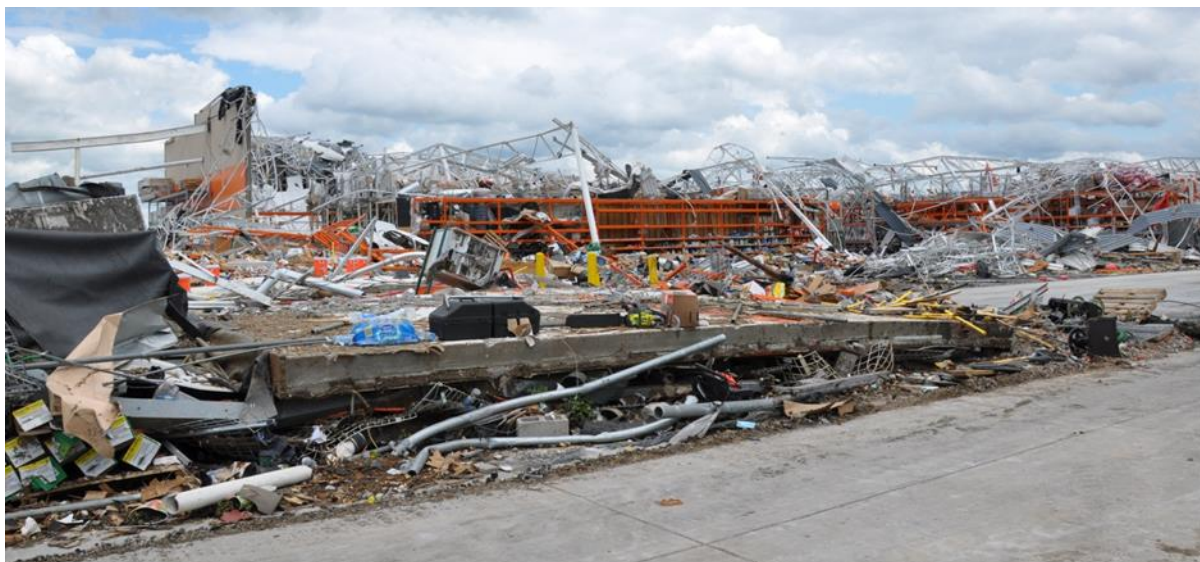
Figure 4–10. A view of the Home Depot building that collapsed in the May 22, 2011, Joplin tornado.

The Home Depot was exposed to an estimated maximum wind speed of approximately 170 mph \pm 20 mph. The concrete wall at the back of the store collapsed outward (i.e., away from the people located in the training room) under the force of the tornado's winds (see Chapter 3 for additional information about the damage to the building). The steel stud and plywood wall of the training room, which separated the room from the rest of the store, toppled over into the training room and rested on top of one of the tables inside the room, leaving a 3 ft "crawl space" available to the occupants. People who had taken refuge inside the training room were able to crawl out of the wreckage nearly unharmed (NIST Interview 152).

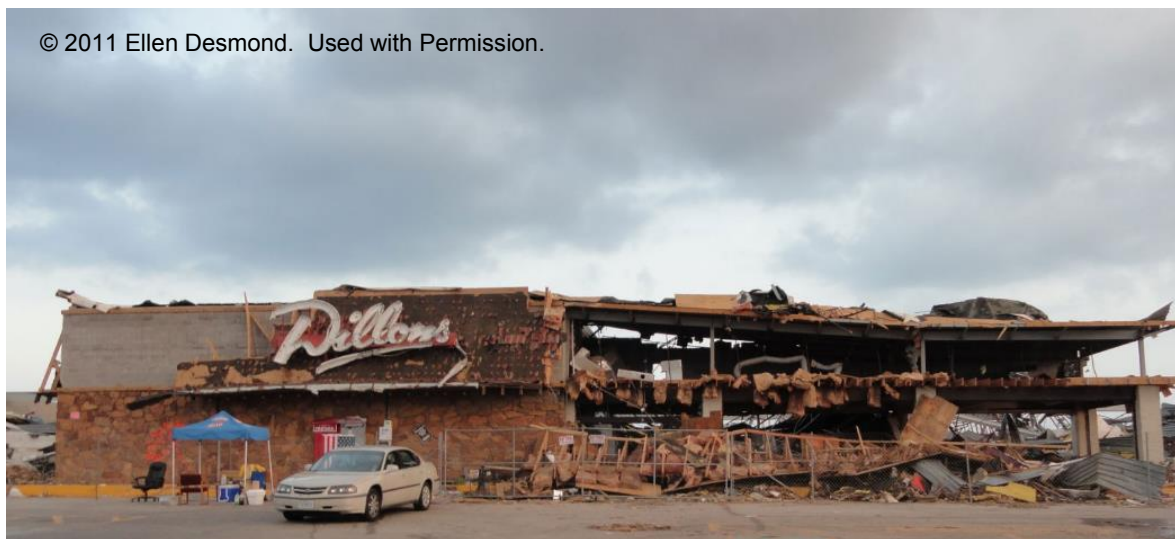
The Dillon’s store was a box-type construction made of CMU perimeter walls and open-joint steel roof trusses. The store was exposed to an estimated maximum wind speed of approximately 170 mph \pm 20 mph. See Fig. 4–11 for damage to the Dillon’s grocery inflicted by the May 22, 2011, Joplin tornado. The tornado caused injuries among building occupants, including cuts, bruises, and scratches; however, none of these injuries was life-threatening.

Figure 4–11. Damage to Dillon’s grocery inflicted by the May 22, 2011, Joplin tornado.

The cooler was located in a corner of the store, against the exterior wall on the western side of the building. After the tornado blew through the building, the cooler remained nominally intact. The cooler doors had popped off and a steel beam had fallen on top of the cooler, which crushed into the back part of it. However, when the tornado was over, the cooler remained standing.

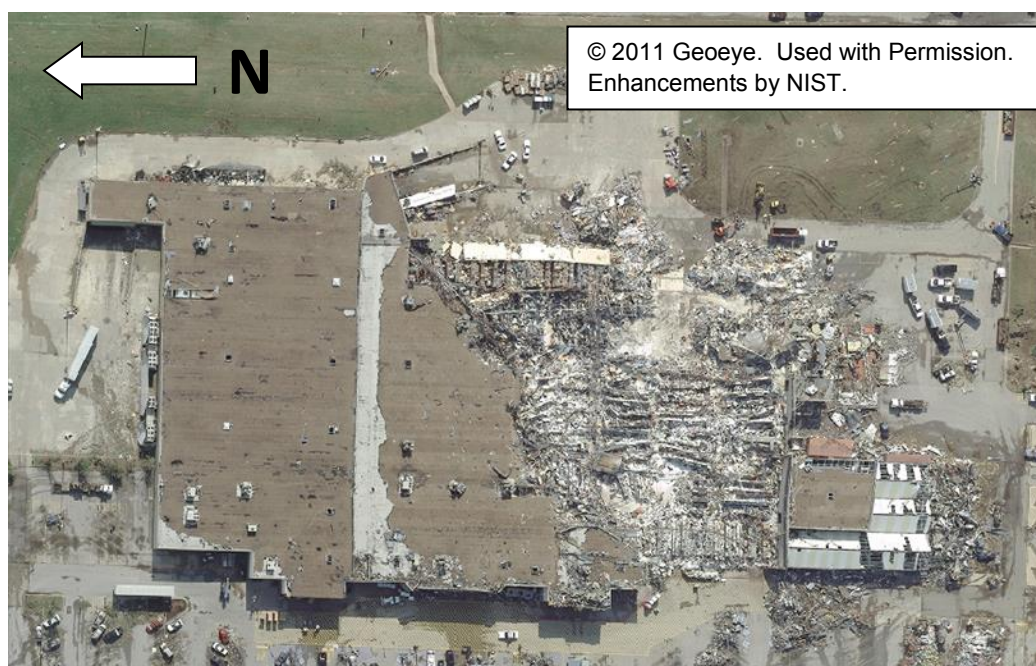
As discussed in Chapter 3, the uncollapsed north half of the building experienced a lower estimated maximum wind speed of $120 \text{ mph} \pm 20 \text{ mph}$ (EF-2 speeds, from a northerly direction) and the collapsed south half experienced a higher estimated maximum wind speed of $165 \text{ mph} \pm 20 \text{ mph}$ (EF-3 to EF-4 speeds, from a west-northerly wind direction) (see Fig. 4-12). A total of three people lost their lives that day in the Walmart. It is uncertain exactly where, inside the store, the fatally injured were located. However, information from the Walmart EOC notes that the fatalities were reportedly the persons closest to the center of the store. All three decedents died due to blunt-force trauma to the body, according to the death certificates. No information could be found on how many did not take shelter in the Site-to-Store refuge area or on the number of people injured at the store.

Figure 4-12. Aerial photo of the tornado-damaged Walmart Store #59, showing the collapsed south half and uncollapsed north half of the building.

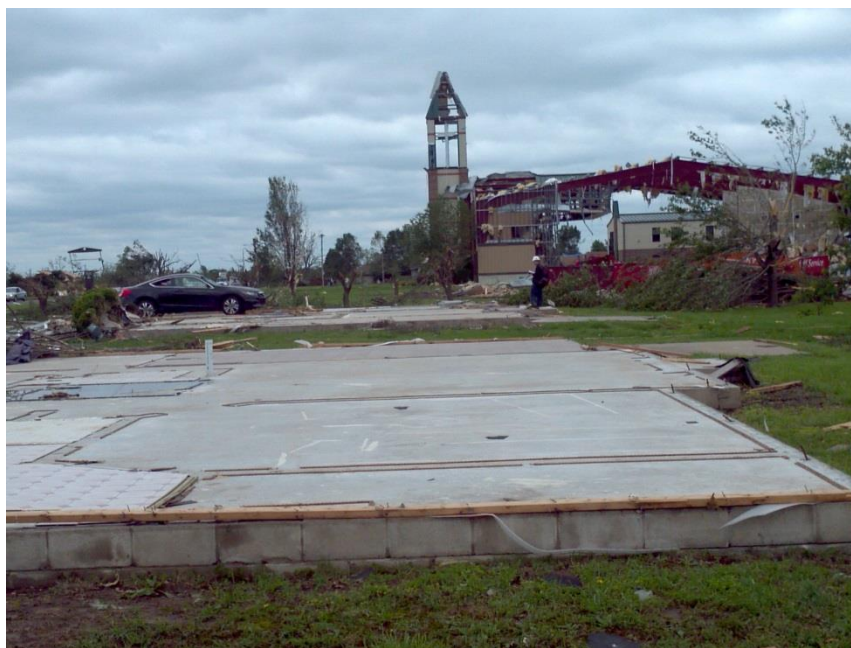
Interviewees suffered anywhere from no damage to their house to the entire house being scraped off of the foundation, with nothing left. Fig. 4-14 shows a foundation and ground floor, all that was left of a house located within the damage path, along with the occupant's vehicle, which before the storm was in the garage. The winds even ripped some of the tiles and carpeting from the floor of this house. The occupant was sent flying into the storm as his house was ripped apart; however he did not suffer any life-threatening injuries.

Figure 4-14. Demolished home located within the tornado damage path in Joplin.

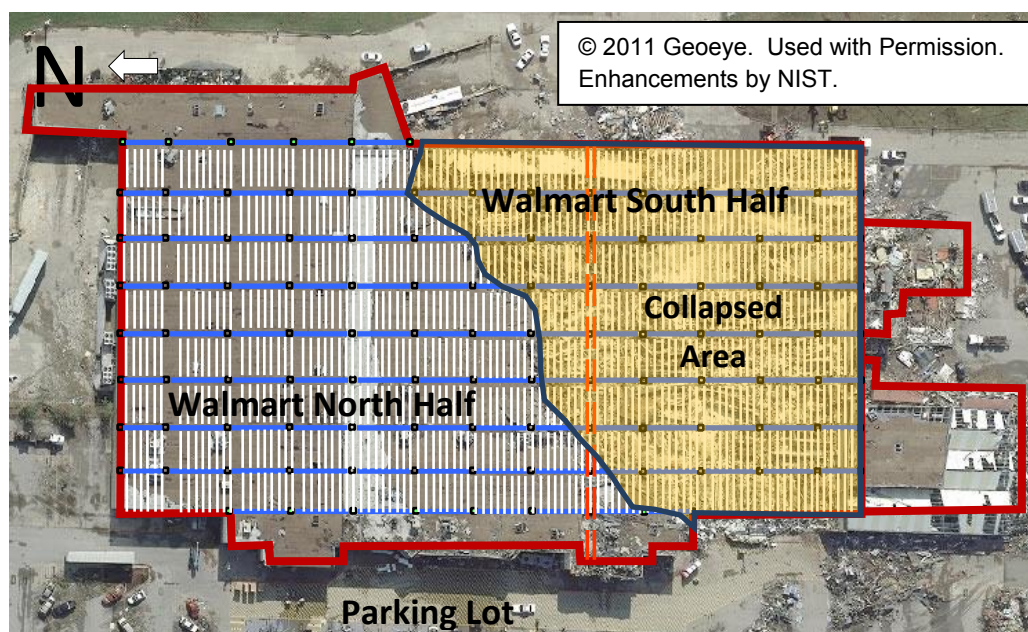
Figure 4–25. Overhead view of tornado damage to Walmart Store #59.

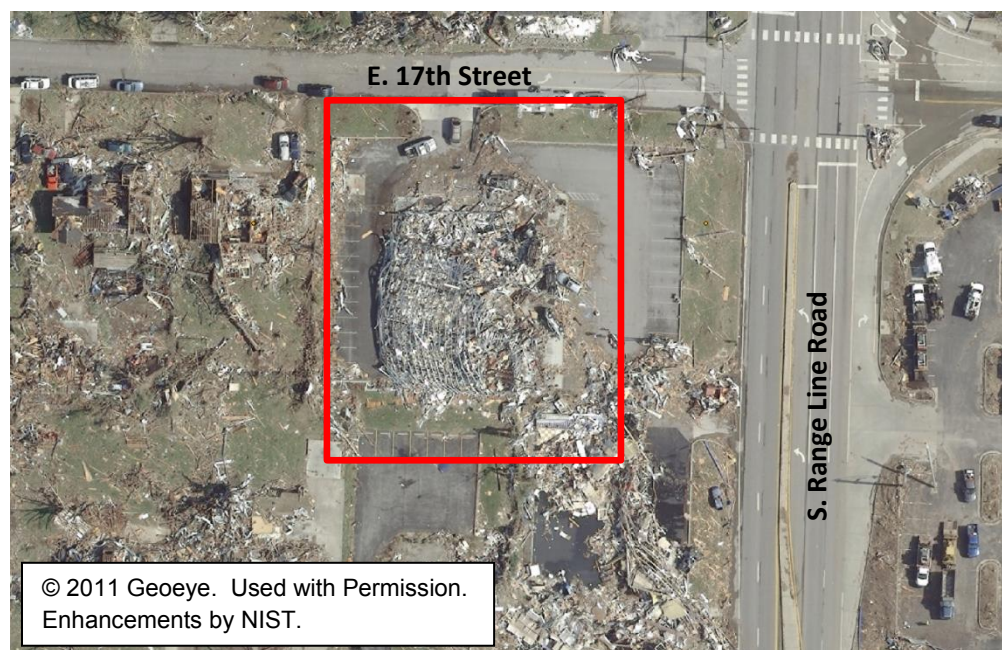
Figure 4–27. Aerial photo showing the AT&T store demolished by the storm (outlined in red).

The first of the buildings in Table 4–6, the AT&T store, sustained complete structural failure with loss of the metal roof decks; disconnection, displacement, and collapse of the entire roof truss system; and complete collapse of all exterior unreinforced CMU walls. In addition, most building components collapsed in place (into all areas of the building interior).

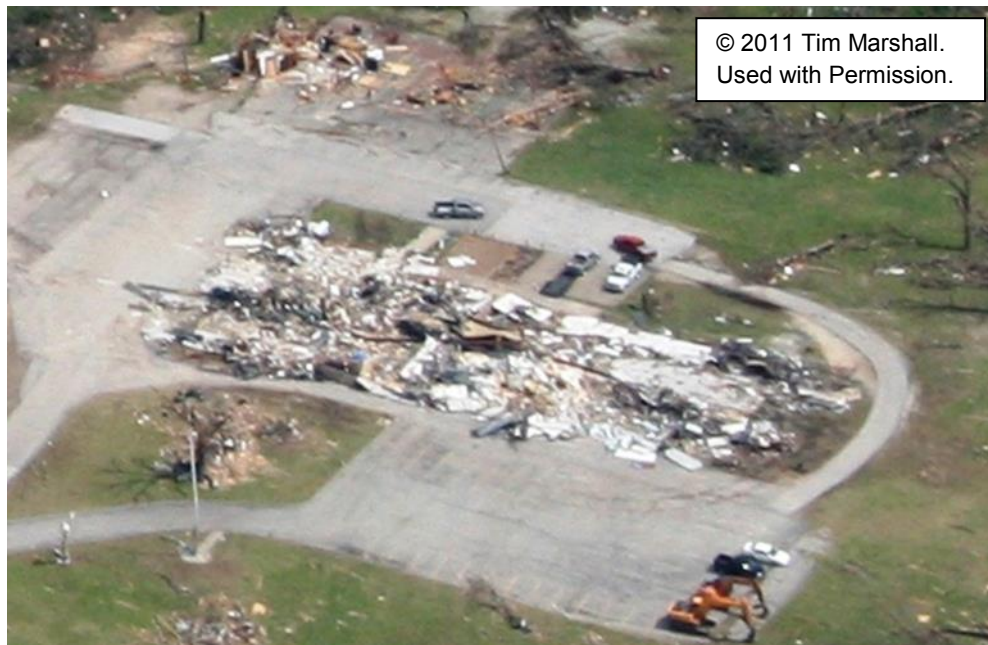
As shown in Fig. 4–28, the Joplin Elks Lodge sustained complete demolition, with disconnection and loss of the entire roof system and complete collapse of the structural wood frame. Similar to the AT&T store, most building components collapsed into the building’s interior due to the storm.

Figure 4–28. Tornado damage to the Joplin Elks Lodge.

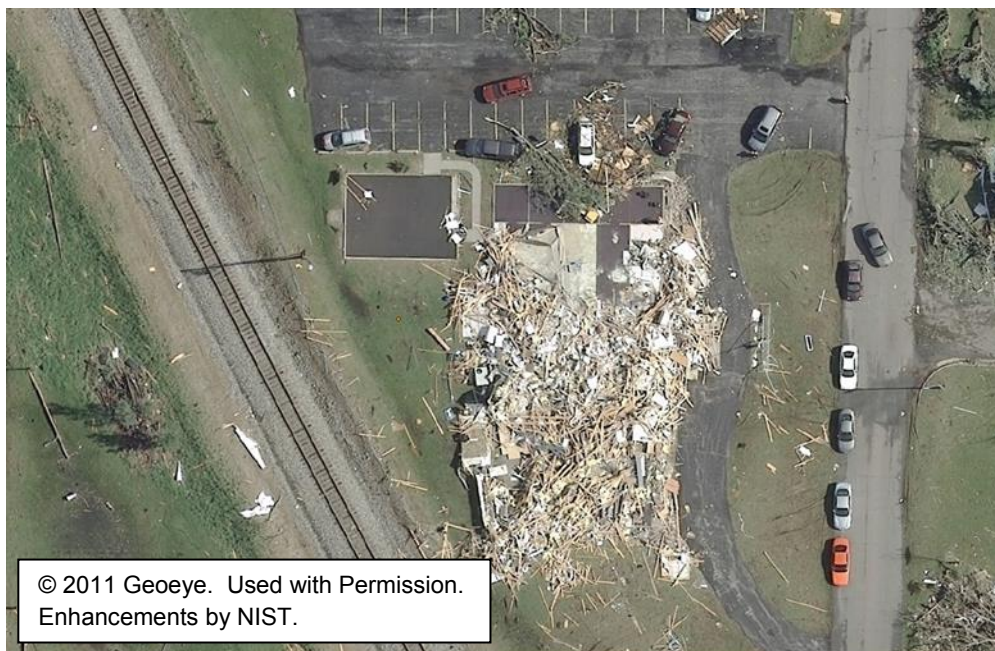
Figure 4–29. Aerial photo showing damage to the Full Gospel Church building.

The Full Gospel Church (Fig. 4–29) was completely demolished, with the entire wood roof system disconnected from the supporting wood-frame walls and disintegrated; and all supporting walls disconnected from the concrete slab foundation and collapsed. Additionally, a significant amount of debris, mostly building materials, ended up in all areas of the building’s interior.

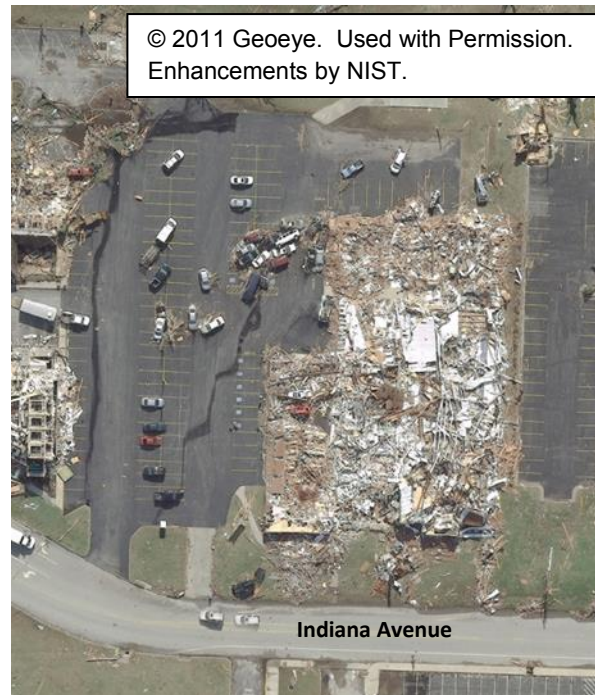
Figure 4–30. Aerial photo showing damage to Harmony Heights Baptist Church.

The Harmony Heights Baptist Church was completely demolished by the storm. The building sustained the loss of the entire wood roof system and complete collapse of all exterior CMU/wood frames. Most debris from the roof and walls ended up in all areas of the building’s interior. The damage is shown in Fig. 4–30.
